Case 243 : Narrative

Case Vehicle (A): 1999 Ford	Vehicle (B): 1987 Cadillac
Type: Crown Victoria LX, 4-door sedan	Type: DeVille, 4-door sedan
Driver: 64-year-old female	Driver: 69-year-old male
CDC: 12-FLEE-8	CDC: 99-0000-0

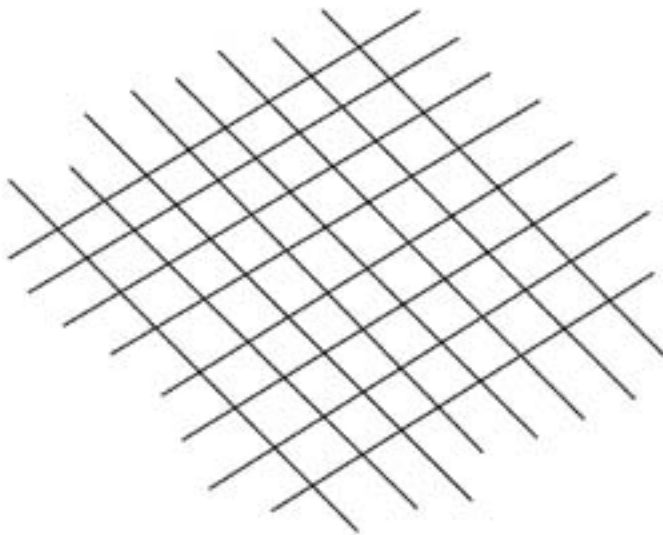
WINDSHIELD MARK ON CASE VEHICLE:

Cracking due to upper A-pillar deformation

Crack due to rear edge of hood contact
